City of Burnsville

Transition Plan

Performing Arts Center

Accessibility Review

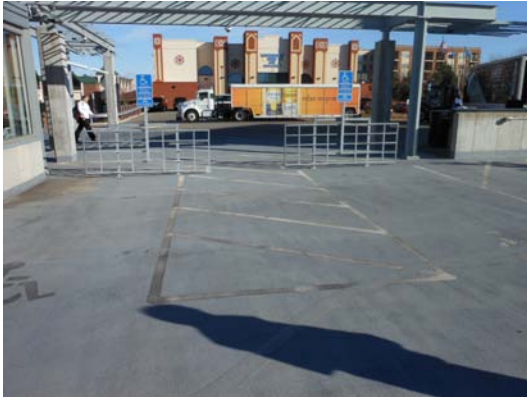
Photo 1: View of accessible parking. Accessible parking spaces with 8' wide aisles are provided throughout the parking facilities.

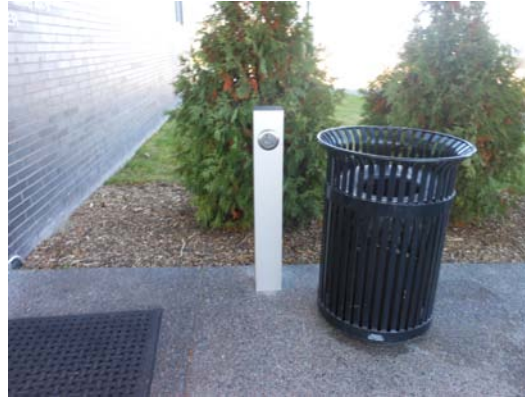
Photo 2: Relocate the trash can so it does not obstruct access to the power door opener.

Location	Solution / Comments	Qty	Unit Cost	Total Cost	Priority	Estimated Compl. Date	Person Responsible	Actual Compl. Date	Actual Cost
JQP # / Item #									
Main Entry- North									
14001		1	\$0	\$0	1				
	<i>Relocate the trash can so it does not obstruct the power door opener control. Photo 2.</i>								
				Priority # 1 Total	\$0

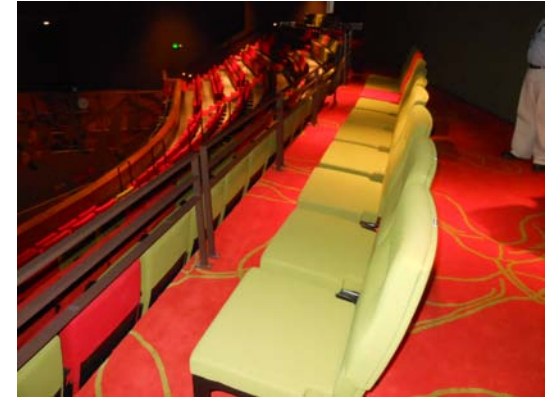
Photo 3: View of wheelchair positions in auditorium. The chairs can be removed or used as companion seating.

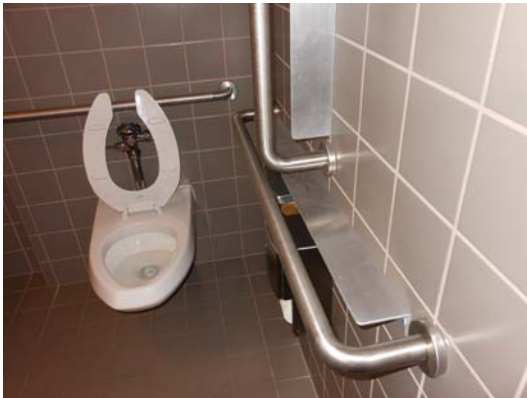
Photo 4: Replace the grab bars with a style that is 1 1/2" from the wall (currently 4") in the 2nd floor men's toilet room and family toilet room.

22F2 (MN)	13984 As the fixture count in the male companion toilet room is greater than or equal to six (combination of stalls and urinals), the female toilet room must also provide an ambulatory accessible toilet stall, even if the fixture count in the female toilet room is less than six. Reconfigure stall partitions to create a fully compliant 36" wide, ambulatory accessible toilet stall. MN 1341 1109.2.2 <i>The companion women's toilet room has more than 6 fixtures.</i>	1	\$1,350	\$1,350	3				
22H1	13983 Provide staple style pulls on both sides of the accessible stall door near the latch. ANSI 604.8.3	1	\$50	\$50	3				
22K6 (MN)	13986 Remove the existing grab bar configuration and replace with a compliant grab bar configuration. MN 1341 604.5.1 ANSI 604.5.2 <i>Replace the grab bars with a style that is 1 1/2" from the wall, currently 4". Photo 4.</i>	1	\$400	\$400	3				
				<i>Location Subtotal:</i>					<i>\$1,800</i>

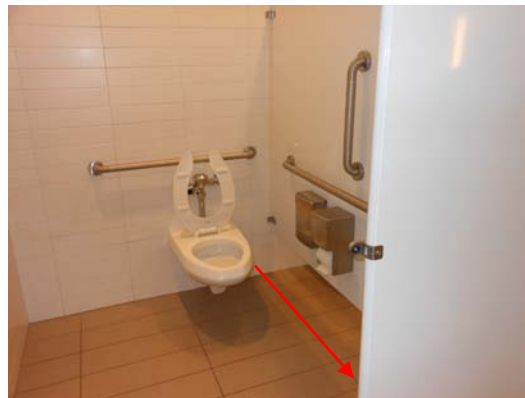
Photo 5: Modify to provide 48" in front of the toilet in the women's toilet rooms (currently provides 45").

Location	Solution / Comments	Qty	Unit Cost	Total Cost	Priority	Estimated Compl. Date	Person Responsible	Actual Compl. Date	Actual Cost
Women's Toilet Room									
22G (MN)	13997 Modify to provide a minimum clearance of 48" in front of the water closet. MN 1341 604.3.1 <i>Currently provides 44". Photo 5.</i>	1	\$1,000	\$1,000	3				
22H1	13996 Provide staple style pulls on both sides of the accessible stall door near the latch. ANSI 604.8.3 <i>In the 5' and ambulatory compartments.</i>	2	\$50	\$100	3				
				<i>Location Subtotal:</i>					<i>\$1,100</i>
Women's Toilet Room- 2nd Floor									
22G (MN)	13982 Modify to provide a minimum clearance of 48" in front of the water closet. MN 1341 604.3.1 <i>Currently provides 45". Photo 5.</i>	1	\$1,000	\$1,000	3				
22H1	13981 Provide staple style pulls on both sides of the accessible stall door near the latch. ANSI 604.8.3 <i>In the 5' and ambulatory compartments.</i>	2	\$50	\$100	3
